SAFO

SAFO 16005
DATE: 5/25/16

Subject: Bombardier Canadair Regional Jets CRJ CL 600-2B19 (200), CL 600-2C10 (700) & CL 600-2D24 (900) Forward Flight Attendant (F/A) Overhead Supplemental Oxygen

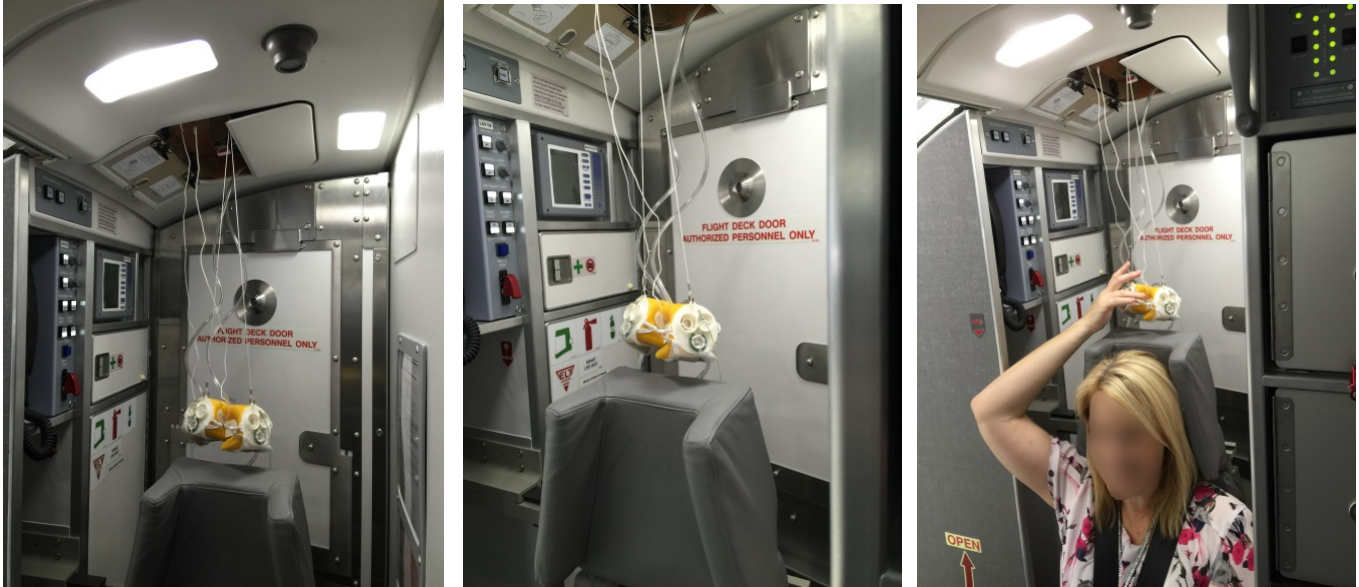
Background: On September 9, 2015, during cruise flight, the captain of a Bombardier CRJ-900 advised F/As to secure themselves in their jumpseats due to turbulence. After they were seated, the aircraft experienced a decompression, which resulted in the deployment of the supplemental oxygen system. The forward seated F/A could see the masks in the cabin; however, she was unable to locate the mask intended for her station. Only after releasing her seatbelt and shoulder harness was she able to locate the masks, which were deployed behind the jumpseat, preventing them from being visible from a seated position.

Discussion: Supplemental emergency oxygen for F/As is located in compartments above crewmember jump seats. The forward F/A supplemental emergency oxygen system compartment is not positioned in vertical alignment with the jumpseat. When a crewmember is seated in the forward jumpseat and masks drop, the masks drop behind the seat and hang out of the crewmember's line of sight, aligned with the back of the jumpseat. To reach the masks, the crewmember must reach up and behind the seat. This poses a potential problem for crewmembers that cannot extend their arms far enough to grasp a mask (see pictures below). Additionally, each mask on the CRJ 700/800 series is fitted with a clip and it provides additional weight and downward pull to the mask. Should an emergency descent be initiated, the aircraft may enter a nose down pitch up to 40 degrees. This would position the masks even further behind the jumpseat and potentially out of reach of the seated crewmember.

Recommended Action: Directors of safety, directors of operations (Title 14 of the Code of Federal Regulations Part 121, 125, 135 and 91K), inflight management and training management should develop procedures and training to instruct F/As on where the forward F/A masks will deploy, be cognizant of the attitude and pitch of the aircraft when mask are deployed and how best to obtain oxygen from a seated position. Flight attendants should be trained to maintain situational awareness for visual indicators in the cabin should a decompression occur.
