**U.S. Department
of Transportation
Federal Aviation
Administration**

Safety Alert for Operators

SAFO 20002
DATE: 2/27/20

Subject: Pratt & Whitney Canada Model PT6A Engines.

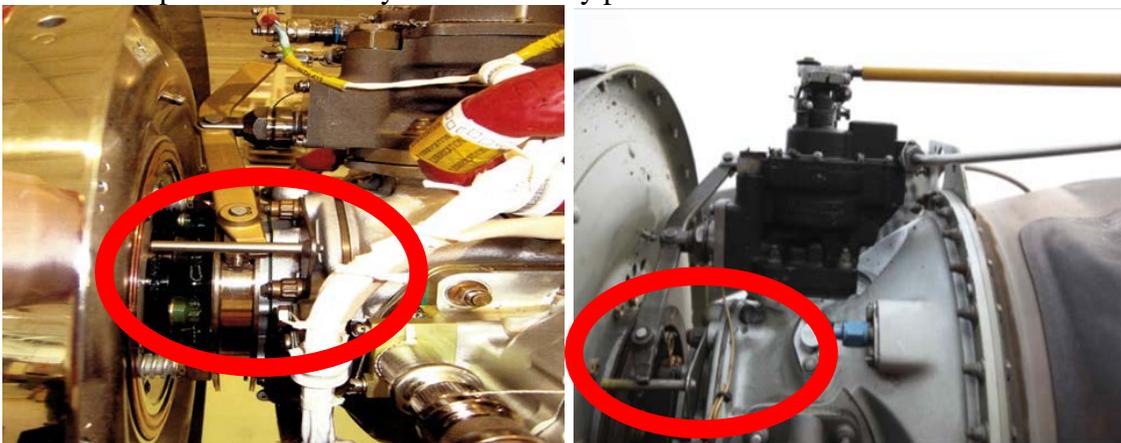
Discussion: The accident investigation revealed a safety issue concerning the possibility of incorrectly installed reversing levers (beta arms) and related components in PT6A engines. If the beta arm is not installed and positioned such that it is secured under its guide pin, the unsecured linkage could release oil pressure in the beta valve and cause uncommanded travel of the propeller to the feather position. Figure 1 shows examples with correctly and incorrectly positioned beta arms.

Figure 1. Photographs of example engines showing correct (left) and incorrect (right) position of the beta arm.

Recommended Action: Maintenance personnel and facilities should visually verify, on Pratt & Whitney Canada model PT6A engines, that the propeller-reversing lever, or beta arm, and guide pin are correctly installed and, if necessary, fix any improper installations. Verification should be accomplished during routine scheduled inspections both before and after propeller installation. Appropriately certificated and qualified technicians should perform these actions. These visual inspections should not only detect errors, but also heighten awareness in the maintenance community about the importance of properly installing the beta arm and guide pin.

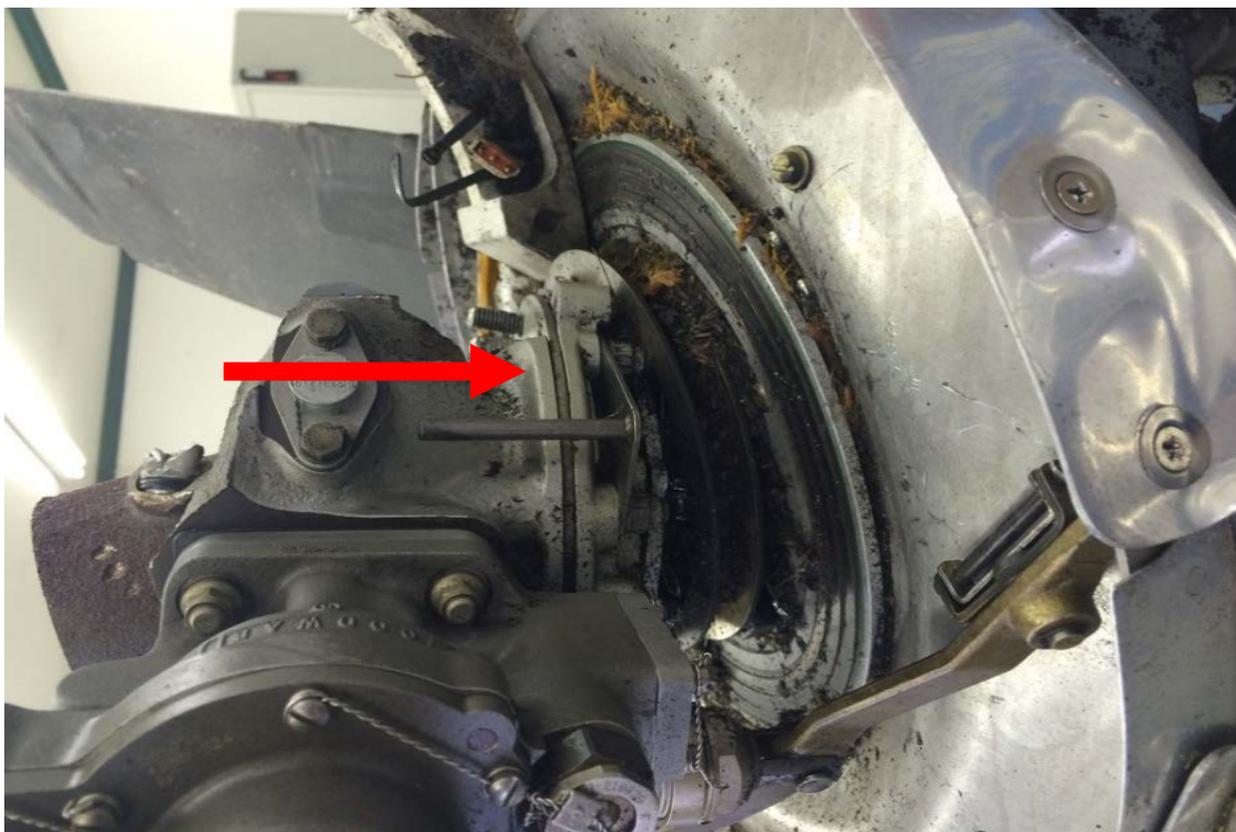
The Federal Aviation Administration (FAA) found five events in which the incorrect position of the beta arm in a PT6A engine was noted, and these occurred within 100 flight hours after maintenance of the beta arm or related components. The fifth event concluded that the guide pin had been installed backward – as shown in Figure 2 - which enabled the beta arm to free-float, or position itself either above or below the guide pin. The FAA is also aware that one operator welded a tab to the top of the guide pin, making it physically impossible to incorrectly install the beta arm over the guide pin. But the operator notes that this fix would not prevent an intentional reversal of the guide pin.

Figure 2. A beta arm guide pin installed backwards. The red arrow points forward, indicating the pin's correct orientation.
